VISUAL TIMBER PEST INSPECTION REPORT

1/3/2006 8:00AM.

1 SAMPLE STREET SAMPLE SUBURB VIC.

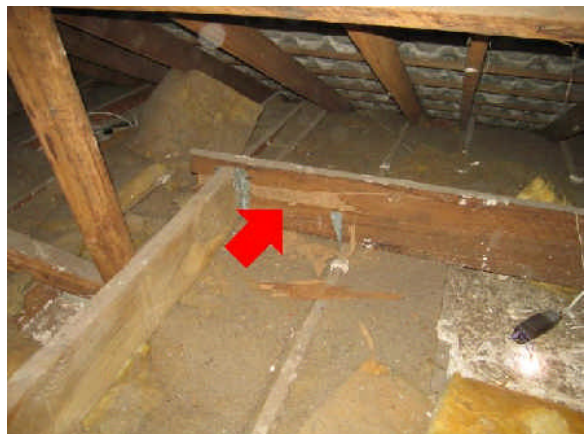
Laundry:

Yes - Inspection revealed currently inactive termite attack (damaged timbers and/or termite workings) within this area including but not necessarily limited to the following timbers and the areas listed below.

Hanging Beam and Top Plate. Hanging beam and supporting timber above laundry area.

Visible timber damage appears severe however, we are not builders and this is not to be considered a builder's opinion. Refer to the definitions section of this report - Section 1.6 - Timber Damage.

Due to comments made in this report regarding timber damage, we recommend that a builder inspect the timber damage and give a qualified opinion regarding same. Refer to building inspection report.

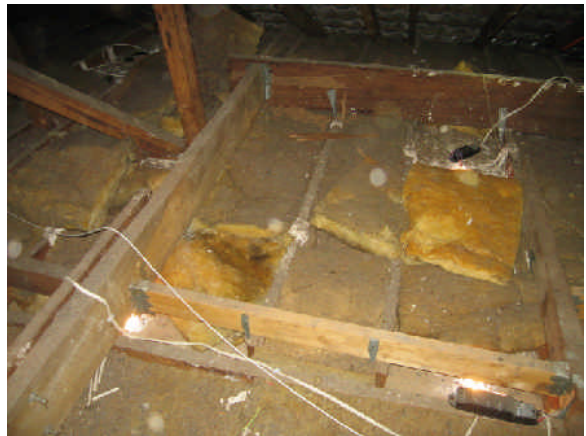
Laundry: Kitchen:

Some timbers (listed below) appear to be new or not the original timbers. This replacement may have been due to timber pest attack or some other factor. We recommend if you are using this report to purchase this property, further enquiries should be made to determine the reason for timber replacement.

Various roofing timbers:
